CHURCH TO STEELE
138 kV REBUILD PROJECT

RAPTOR NEST SURVEY REPORT

MARCH 2014

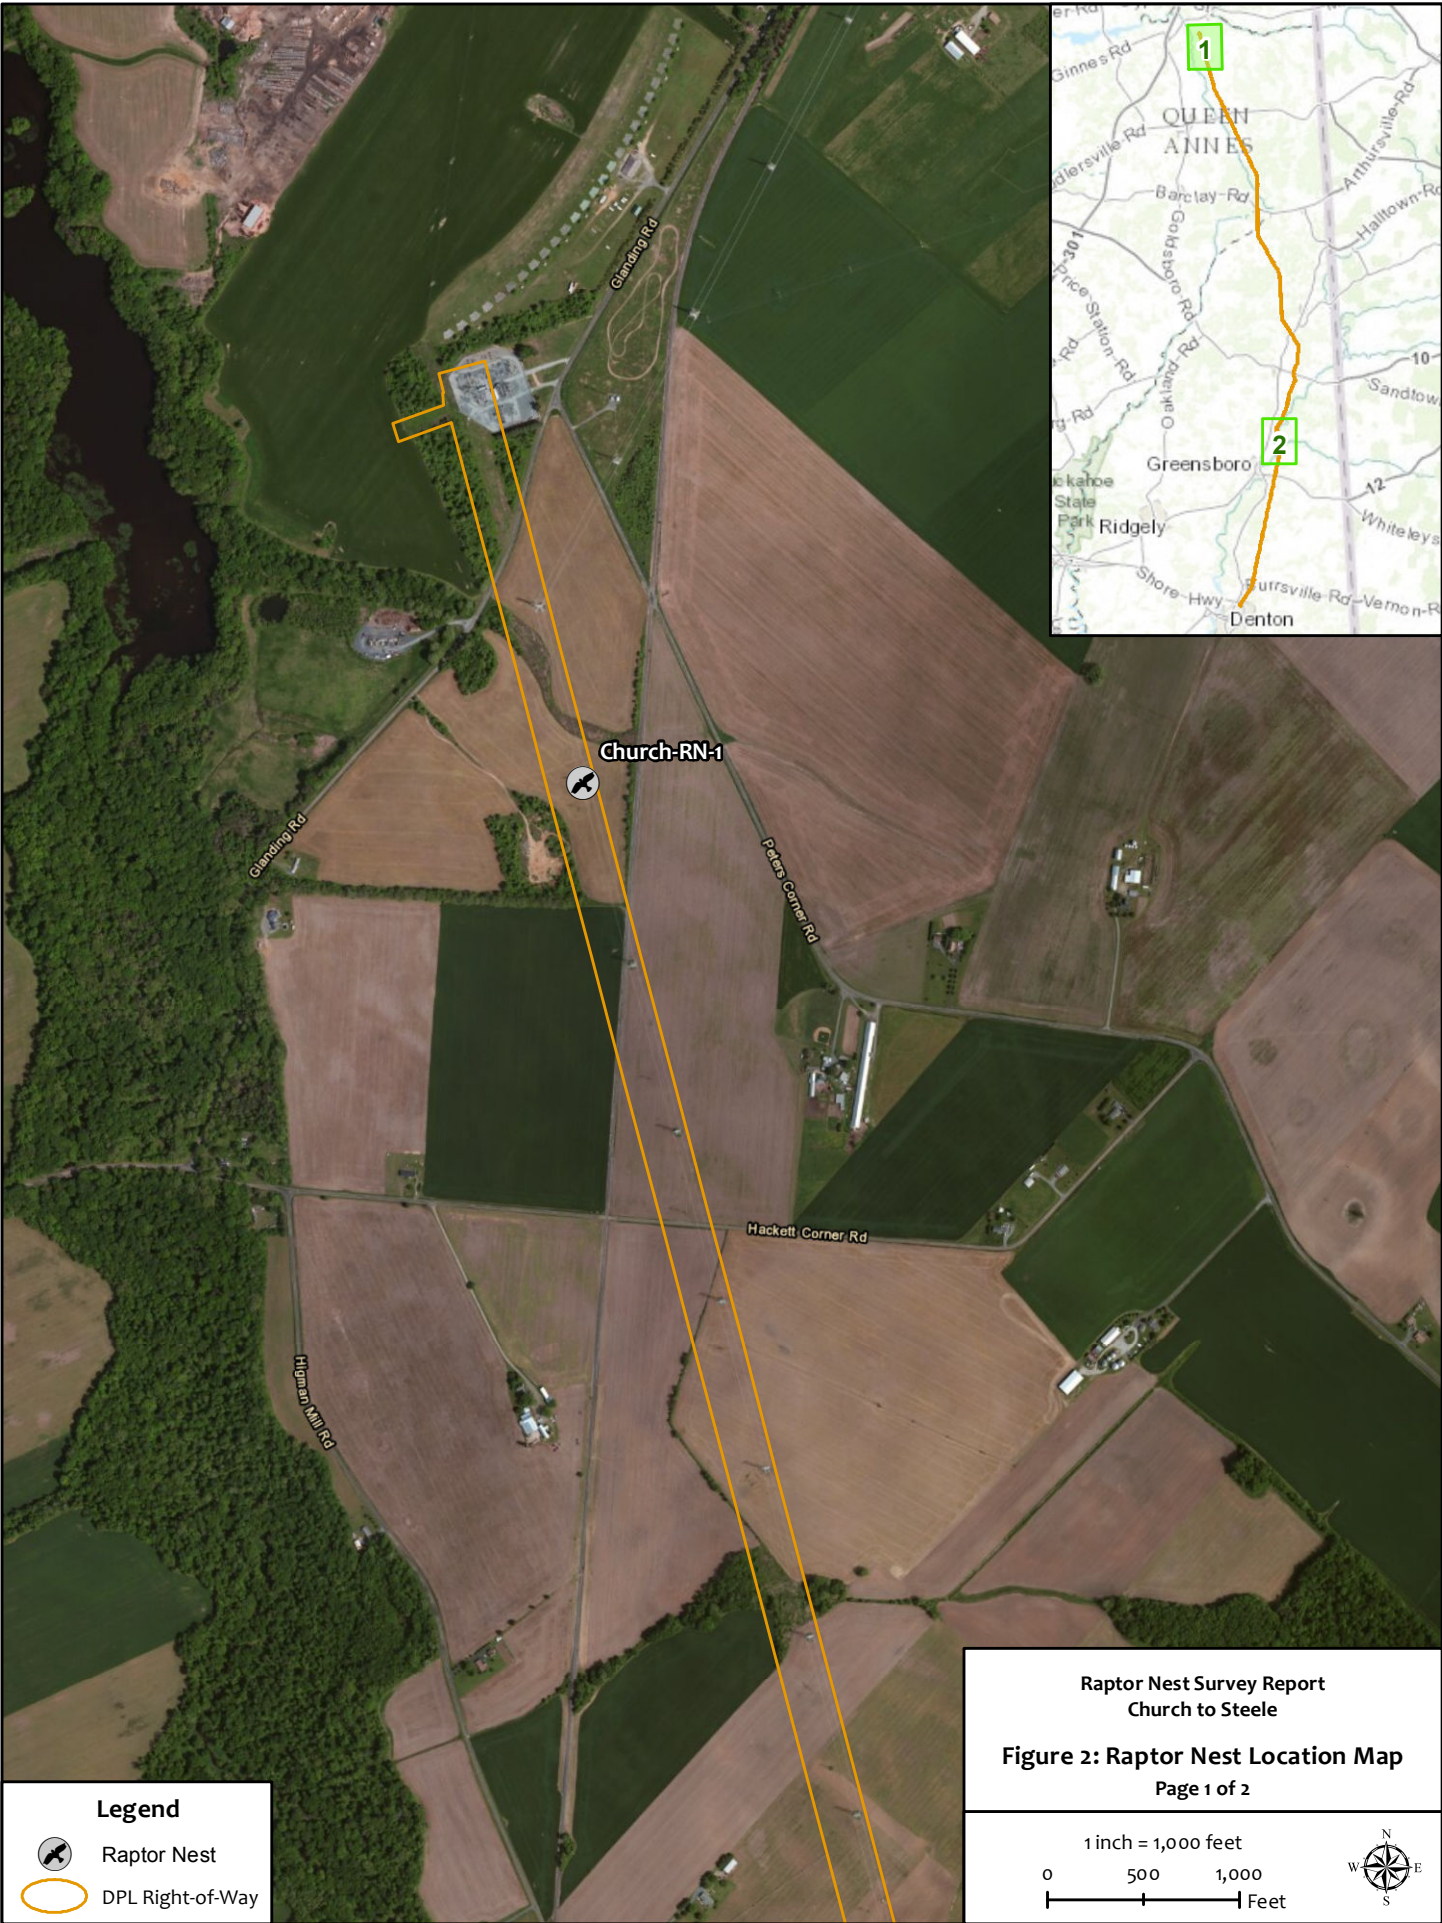
Figure 2: Raptor Nest Location Map
Page 1 of 2

Three raptor nests were observed at three independent locations. One of three nests was identifiable based on size and form; however no determination could be made about the remaining two nest. The nest that could be identified was determined to be from an osprey (*Pandion haliaetus*) based on size and appearance, however it was not occupied at the time of investigation. A summary of survey results is included in **Table 2** and each nest location is graphically presented in **Figure 2**.

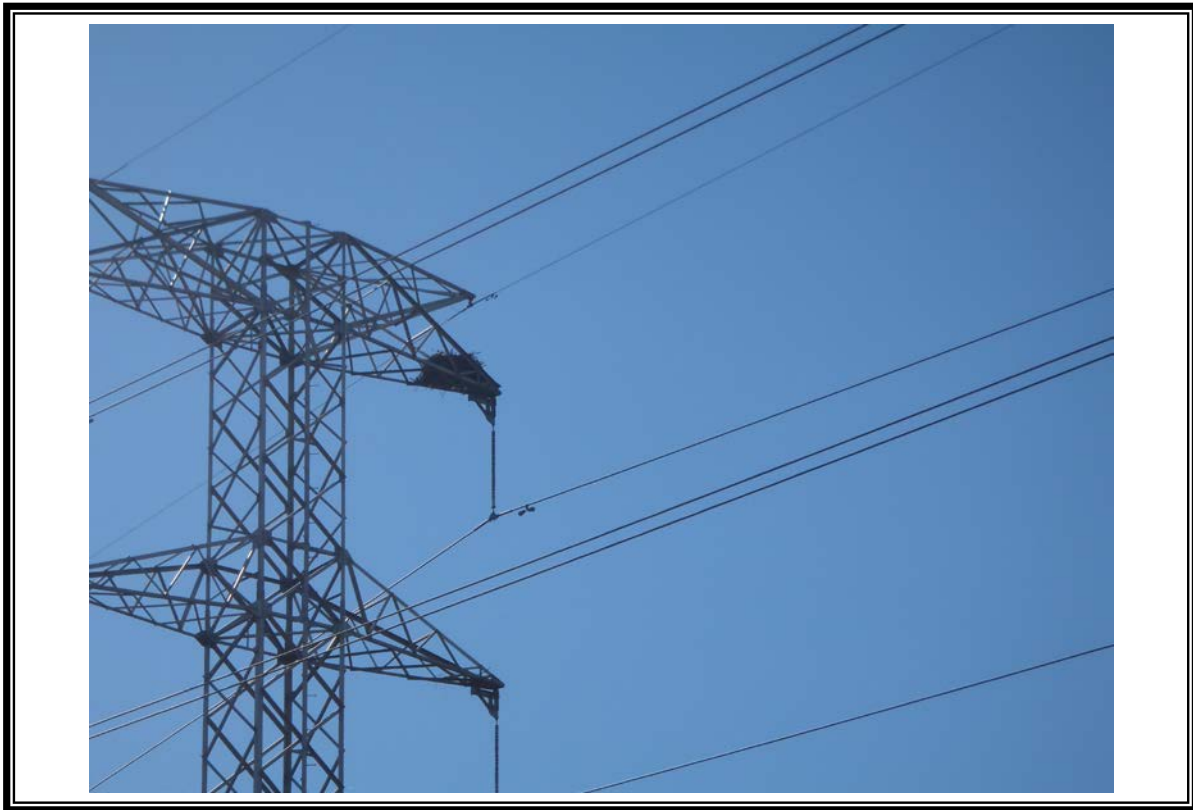
Raptor Nest ID: Church-RN-1 **Date/Time First Observed:** 11/13/13 11:30
Observed By: SA, JB **Powerline ROW Segment:** Church
Species: Unknown
Location: On Tower 313
Nearest Waterbody: Unicorn Mill Pond
Nest Occupied/Active: unoccupied
Evidence of Occupation: No evidence observed below tower.
Nest Substrate: branches **Height of Substrate (ft.):** 1'
Nest Condition: Unknown
Vegetation/Structure Type: Utility Pole
Powerpole ID: 313
GPS Coordinates (Dec. Degrees): Latitude: 39.237105 N Longitude: -75.846805
Remarks/Comments: _____

Photo 1: Church-RN1 is a nest of an unknown species.

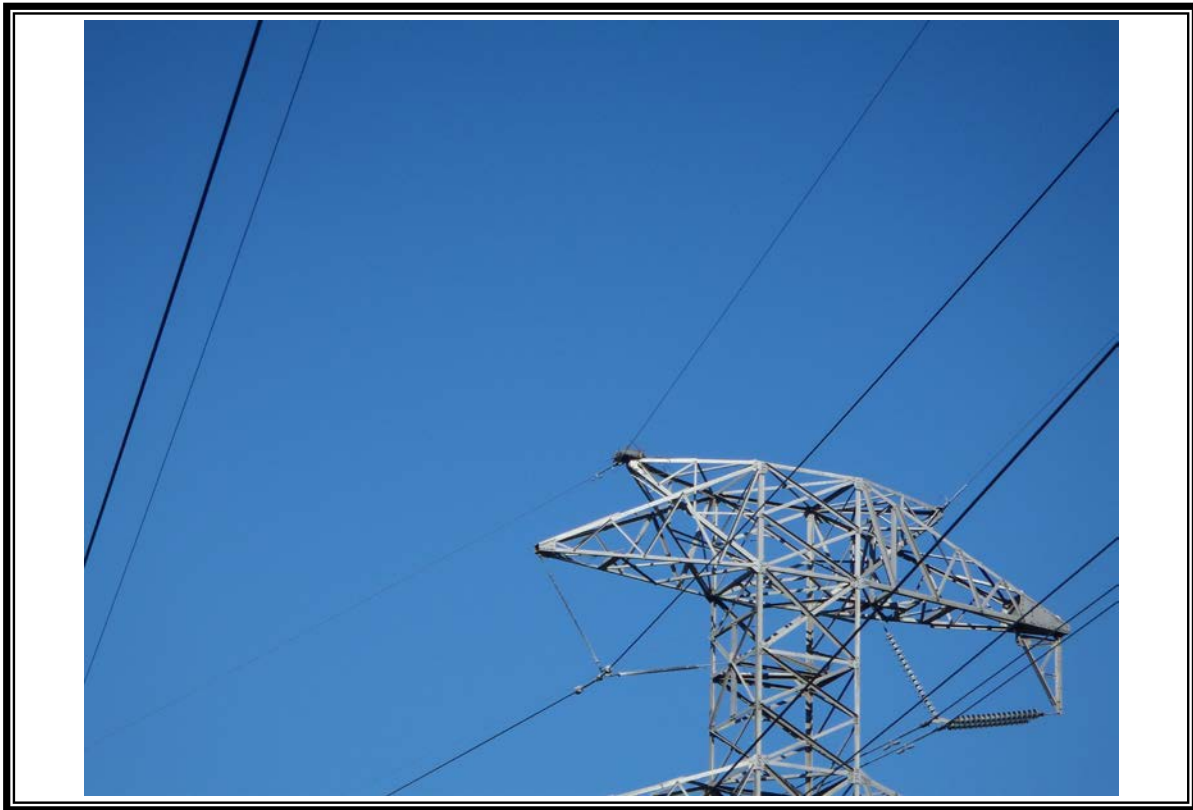
Raptor Nest ID: Broadway-RN-1 **Date/Time First Observed:** 11/18/13 13:30
Observed By: SA, JB **Powerline ROW Segment:** Broadway
Species: Unknown but probably osprey based on size of nest
Location: Broadway segment next to WET5
Nearest Waterbody: Choptank River within 2,000 feet
Nest Occupied/Active: unoccupied
Evidence of Occupation: No evidence observed below tower.
Nest Substrate: branches **Height of Substrate (ft.):** 1'
Nest Condition: Unknown
Vegetation/Structure Type: Utility Pole
Powerpole ID: 437
GPS Coordinates (Dec. Degrees): Latitude: 39.001108 N Longitude: -75.788375
Remarks/Comments: _____

Photo 1: Broadway-RN1 is a possible osprey

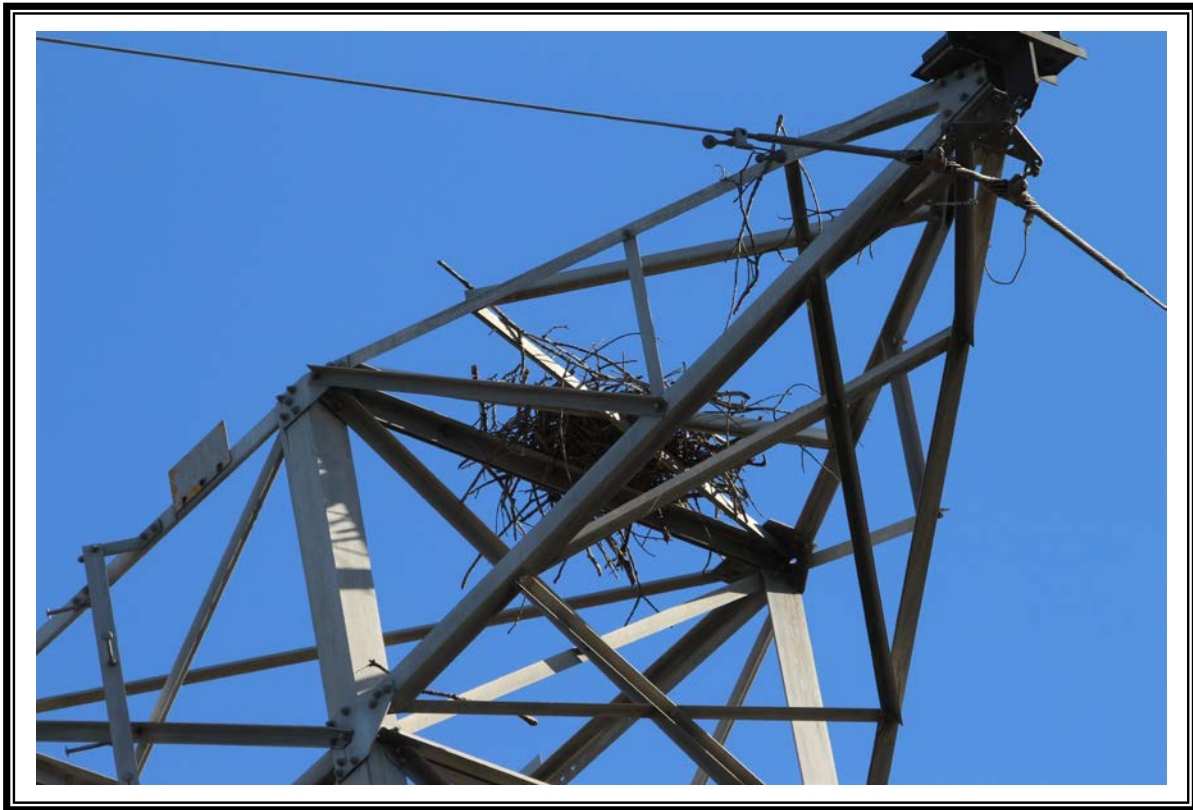
Raptor Nest ID: Red Bridges-RN-1 **Date/Time First Observed:** 11/19/13 13:45
Observed By: SA, JB **Powerline ROW Segment:** Broadway
Species: Unknown
Location: Tower 444 along Red Bridges segment
Nearest Waterbody: Choptank River
Nest Occupied/Active: unoccupied
Evidence of Occupation: No evidence observed below tower.
Nest Substrate: branches **Height of Substrate (ft.):** 1'
Nest Condition: Unknown. Nest is unfinished or has been mostly dismantled.
Vegetation/Structure Type: Utility Pole
Powerpole ID: 444
GPS Coordinates (Dec. Degrees): Latitude: 38.986559 N Longitude: -75.785443
Remarks/Comments: _____

Photo 1: Red Bridges-RN1 is a nest of an unknown species.
